# Proposed Alterations Design and Conservation Statement Kinlochaline Castle Ardtornish Morvern Argyll

Jane Stewart Smith & Hugh Raven March 2015

# JRA John Renshaw Architects

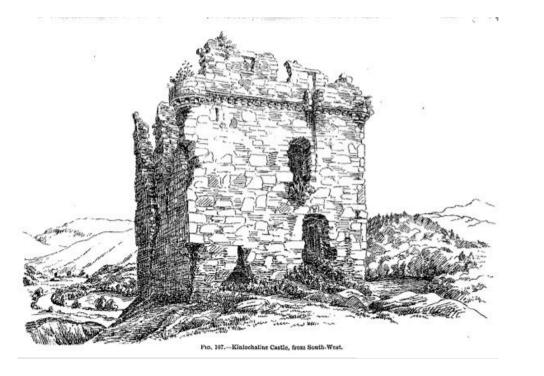
Figure 3 - FIG. 107.-Kinlochaline Castle, from South-West MacGibbon and Ross v.3 p 169)

The castle was surveyed by MacGibbon and Ross during 1889 when MacGibbon noted that it was "... sadly mutilated, but it still retains the fine corbel-course of the parapet and angle turrets." See Figure 12 below for drawing of view from south-west.

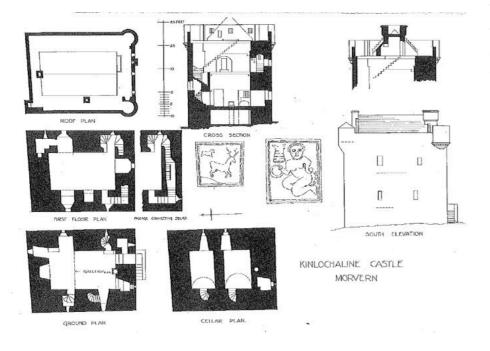
*Figure 3a - Plans, sections and details (Ardtornish Estate Archive)*

The castle was restored around 1890 for Mr. Valentine Smith, the proprietor of Ardtornish estate, probably by the Inverness architect Alexander Ross, (Ross and Macbeth). The broken walls and parapets were rebuilt with much new stonework and a good deal of imagination. The stairs were renewed, and a new steeply pitched roof constructed, believed to match the original roof pitch. It was finished with corrugated iron sheets.

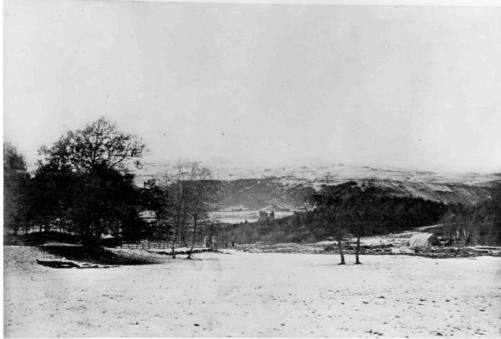
Figure 9 - Gertrude Smith c.1865 - 1875 The ruins of Kinlochaline Castle from the east showing the extensive breach in the east wall

By the mid 19<sup>th</sup> century the structure was extensively damaged with huge vertical gashes in the masonry of the east and west walls. This is clear from the painting by Horatio McCulloch dated 1855 and the photographs taken by Gertrude Sellar, daughter of the proprietor Octavius Smith, dating from c.1860s.

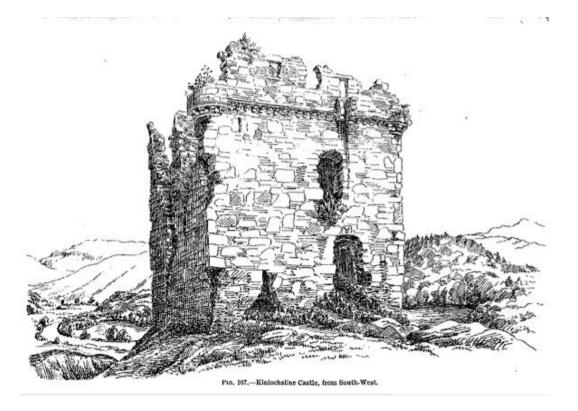
Figure 13 - FIG. 107.-Kinlochaline Castle, from South-West MacGibbon and Ross v.3 p 169) 1889.

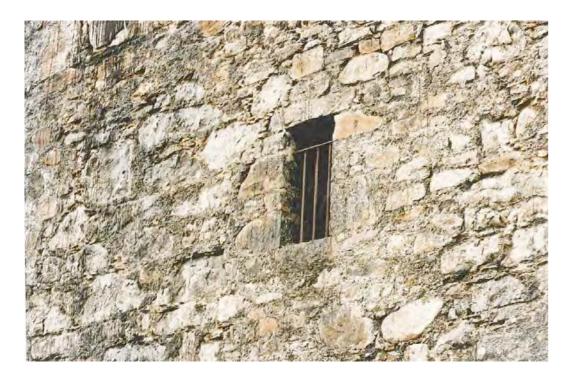
Figure 21 - Detail of window, prior to renovation and reuse as family dwelling 1998 JRA

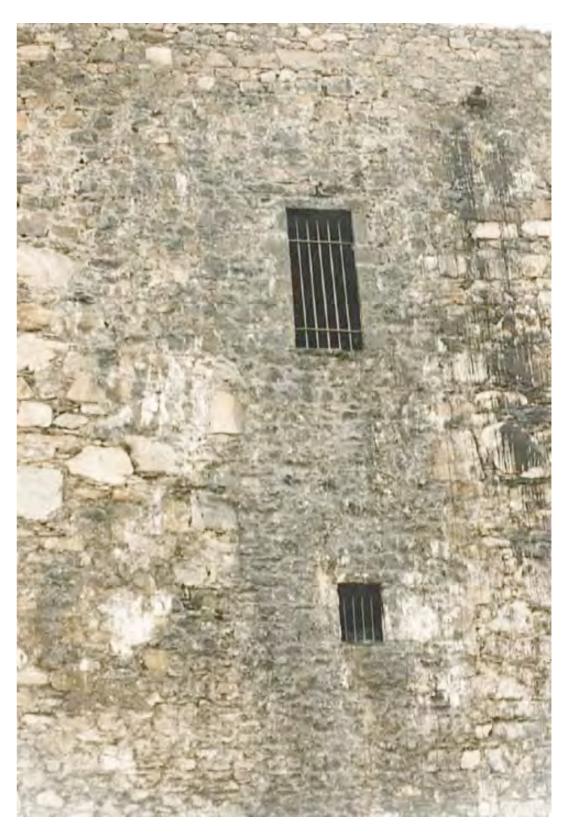
Figure 22 - Detail of West elevation 1998 JRA clearly showing extent of 19<sup>th</sup> c. masonry infill and restoration using predominately schist rubble

The castle was built of fossiliferous limestone, mica schist and basalt rubble masonry. The limestone, which outcrops locally, rubble dates from the earliest phase(s) of construction and the mica schist and basalt have been extensively used in every period of construction and alteration, particularly in the late 19<sup>th</sup> century restoration. Most of the free stone dressings were robbed and the structural openings made good with rubble in the 19<sup>th</sup> century restoration.

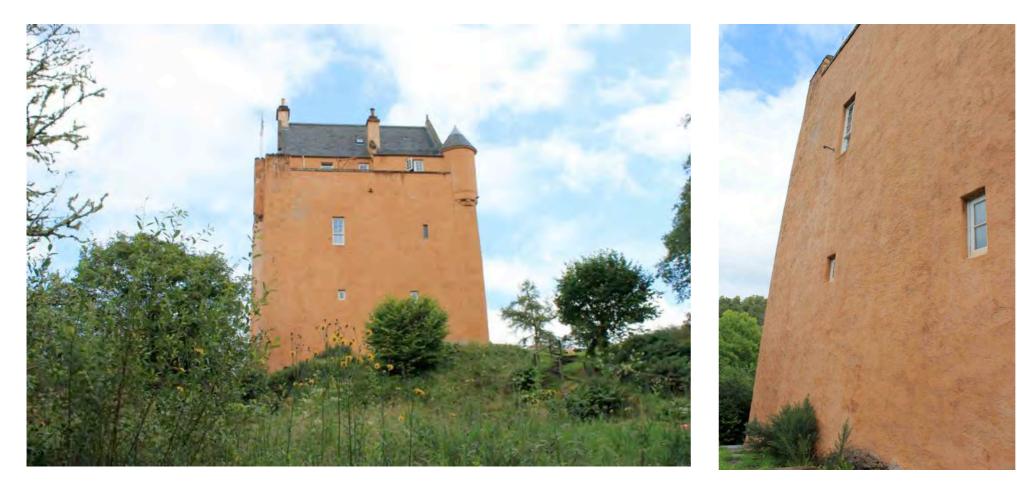
Figure 27 - West elevation, c.2014 (JRA)

Figure 28 - Detail of existing windows on West elevation, c.2014 (JRA)

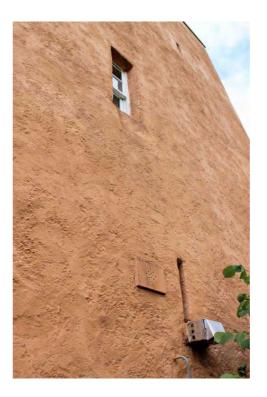
Figure 29 - Detail of existing windows on East elevation, c.2014 (JRA)

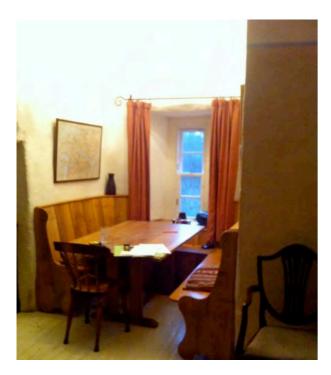
Figure 30 - Detail of eastern window embrasure in Kitchen, 2015 (JRA)

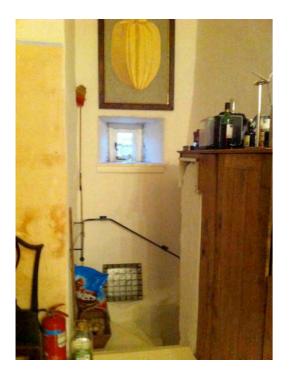
Figure 31 - Detail of western window recess and stair to basement cellars, 2015 (JRA)

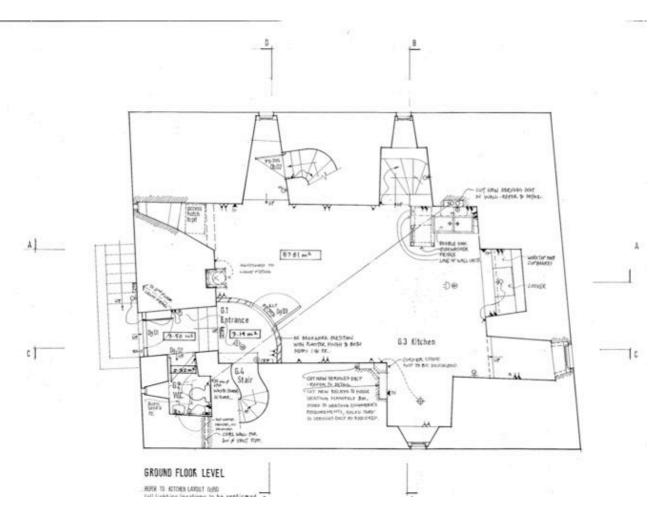
*Figures 32 & 33 - Plan and section showing the extent of masonry rebuilt during the1890s restoration.*

The masonry structure forming the two window openings on the east and west elevations date from the 1890's restoration and is neither authentic to the original medieval structure nor a significant examples of late Victorian castle restoration.

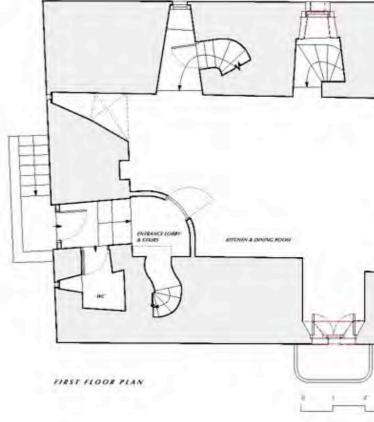
Z	P.
	dan birnash hindi di tingi Kana Kalendara Carle Pegnad Abrelian te Weislane Pegnad First Fiar Fiar Abben KE Applicatio	Hald-10 charges agen- 46.10 11.00 11
a a s motres	) R A	March 1975 Michael Holder Hildery (1010) Software Minamore (1987

- a small fixed leaded light 150 x 605mm on the south elevation;
- a double glazed sash and case window 470 x 930mm and a timber casement window 460 x 620mm on the west elevation;
- a double glazed sash and case window 700 x 1670mm on the north elevation; and
- a double glazed sash and case window 460 x 1375mm on the east elevation.

The proposed external materials will match the existing hydraulic lime harl and traditional lime wash. The proposed lintols will be of pre-stressed concrete. The internal wall finished will also be reinstated to match the existing late 20<sup>th</sup> century finishes.
